# *Ohio Home Inspection Organization*

## **Property Inspection Report**

123 Main Street, Mayberry, Ohio 43555  
Inspection prepared for: John & Jane Doe  
Real Estate Agent: -

Date of Inspection: 7/13/2013 Time: 9:00 AM  
Age of Home: 1976 Size: 1328 Sq. Ft.  
Weather: 80 Sunny

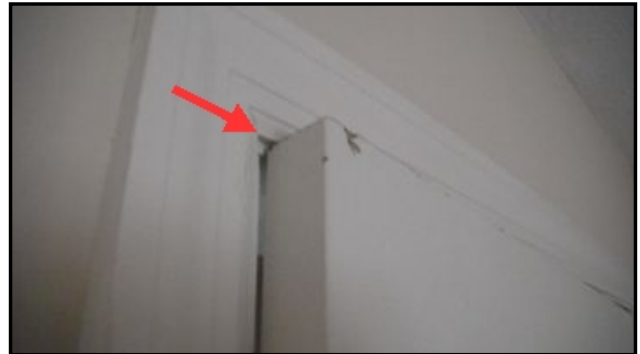
Door doesn't close properly, upstairs closet

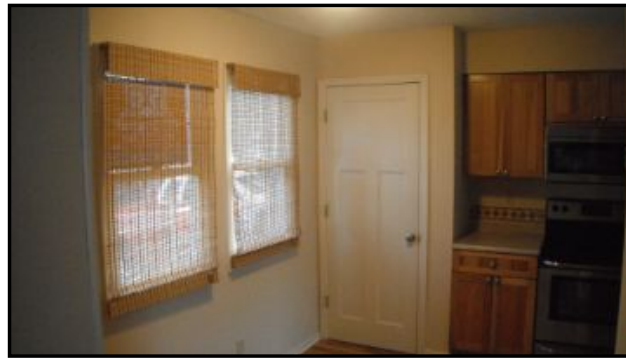
- Windows were not able to be opened, this may be because of the paint.

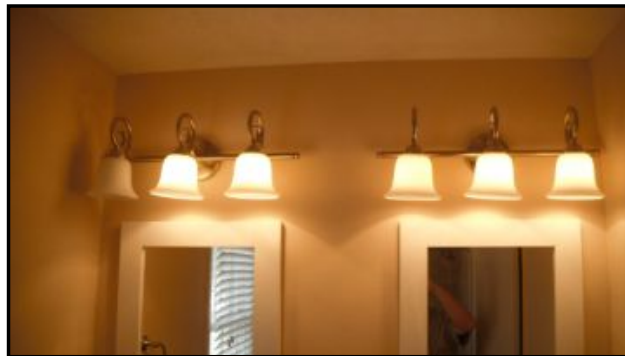
- All of the switches for the lights and exhaust fans worked properly at the time of inspection.
- One of the light bulbs in the upstairs bathroom was burned out.

Upstairs bathroom light burned out

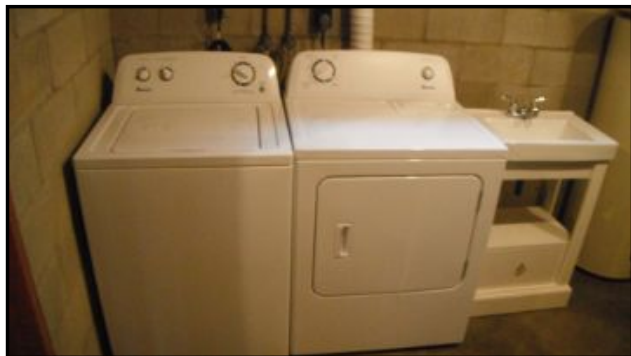
- The wash basin seems to be in good condition, however, it is not connected to plumbing.

Wash Basin is not connected to plumbing

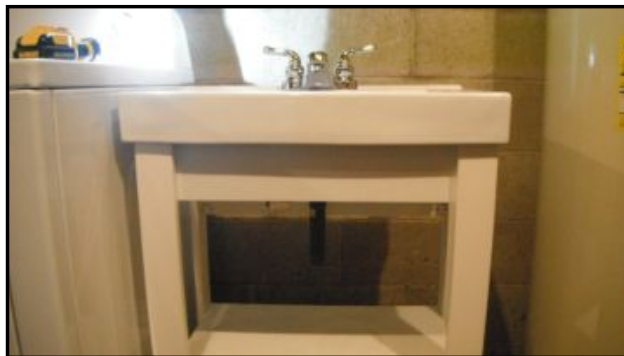
Not connected

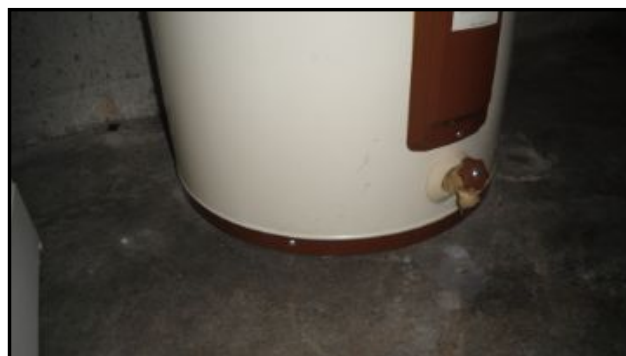
Appears to be sitting on floor, suggest sitting on bricks or wood blocks to prevent condensation/rust

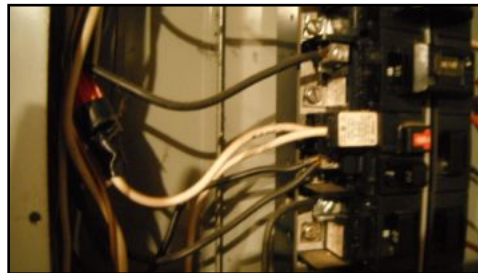
GFCI Breaker

- Observed a GFCI breaker in the panel box, unsure where it goes or what it feeds.
- No major system safety or function concerns noted at time of inspection at main panel box.

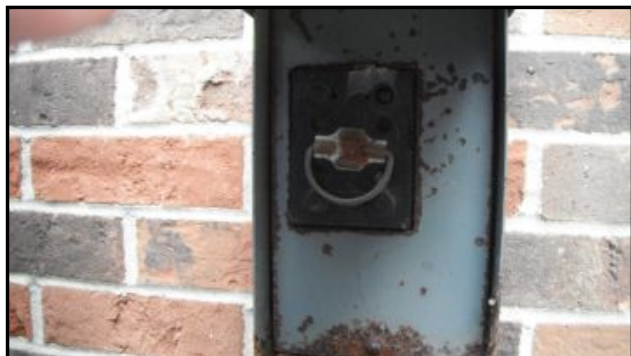
Appears to be original equipment, some rust noted

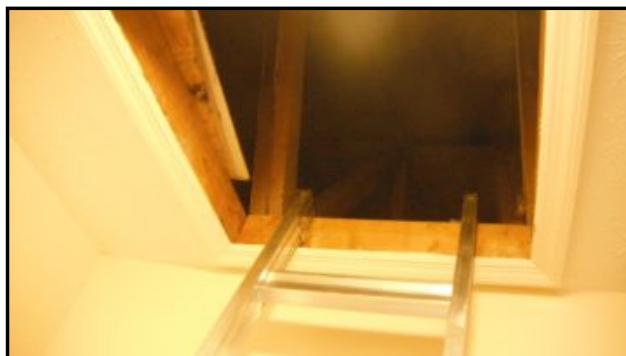
- Scuttle Hole located in:
- Bedroom Closet.
- IMPROVE: The attic access is not insulated. Expect some energy loss through convection. Recommend insulating attic access hatch cover with a batt of fiberglass insulation to reduce energy expenses.

Suggest adding insulation to back side of access panel

- No insulation over attic hatch; recommend installation, then sealing hatch with caulk to minimize heat loss.
- Insulation appears adequate.

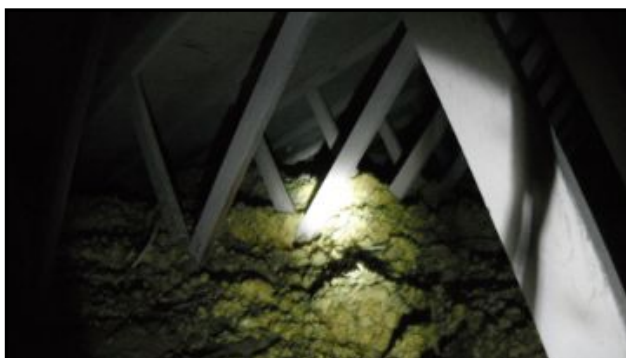
Not even/consistent, but seems adequate

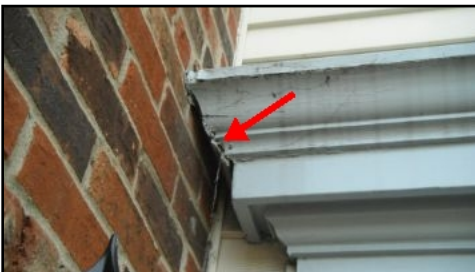
Caulking to prevent moisture intrusion

- Caulk and seal all gaps, cracks and openings to prevent moisture and/or pest intrusion.

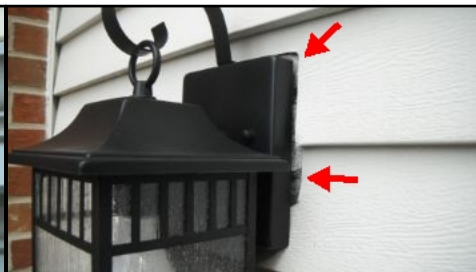
Caulking to prevent moisture/pest intrusion.

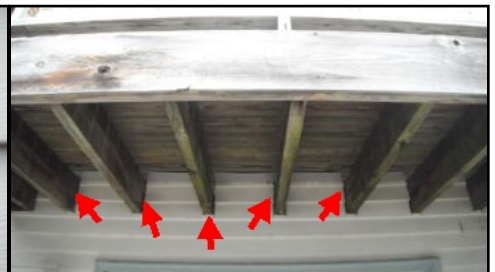
Caulking to prevent moisture/pest intrusion

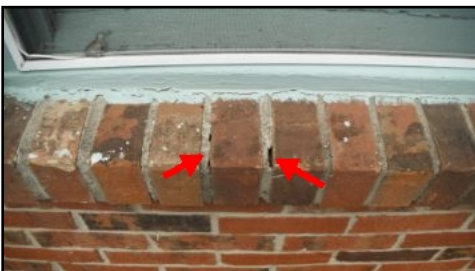
Mortar joints deteriorating

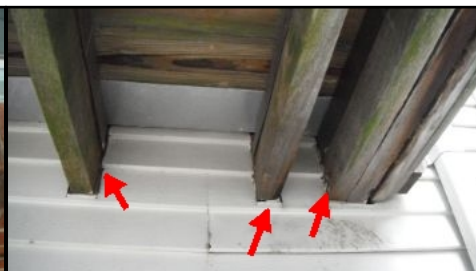
Caulking to prevent moisture/pest intrusion

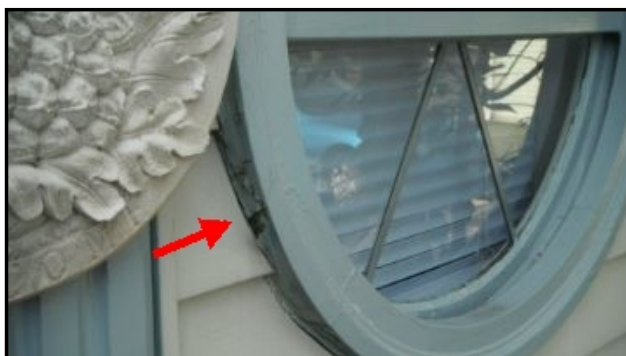
- Peeling paint observed, suggest scraping and painting as necessary.
- Suggest sealing/caulking as part of routine maintenance to prevent further deterioration.

Paint peeling

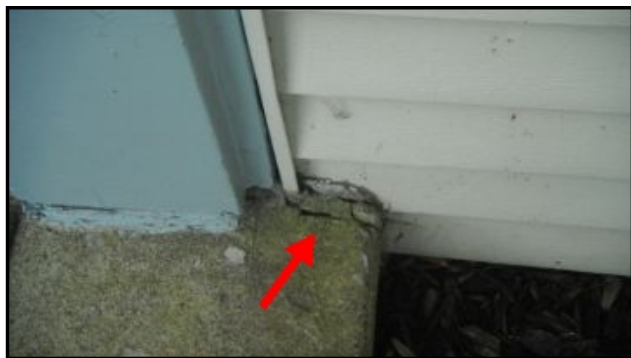
- IMPROVE: Typical cracking was observed at the concrete surfaces. Further deterioration will occur as water expands and contracts from freeze and thaw cycles. Recommend sealing the cracks to prolong the life of the concrete.

Concrete chipping/cracking

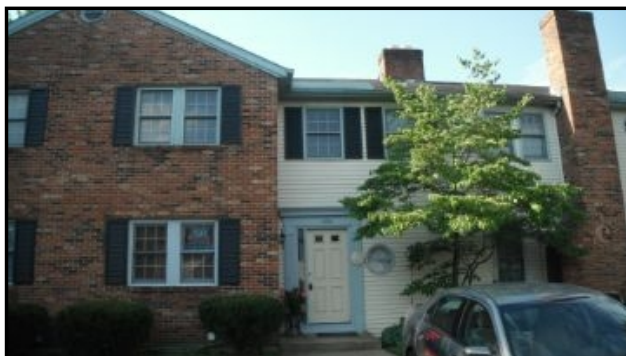
- Trees are within 6 feet of foundation. Monitor for potential root damage.

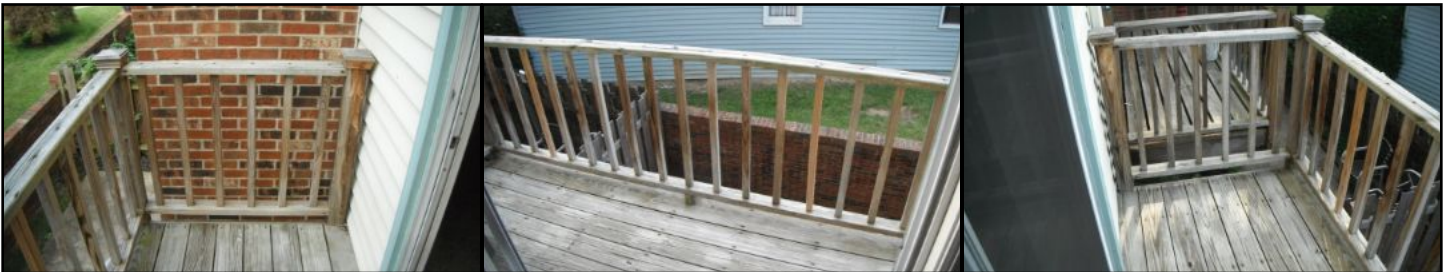
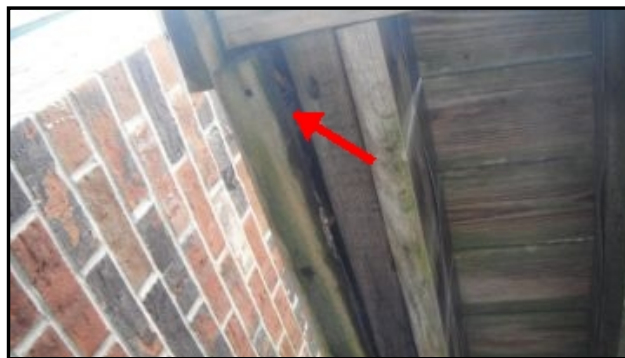
- Appears in satisfactory and functional condition with normal wear for its age. Appears to be sound structure.
- Rotted Wood.

Cantilever balcony floor joist is rotting

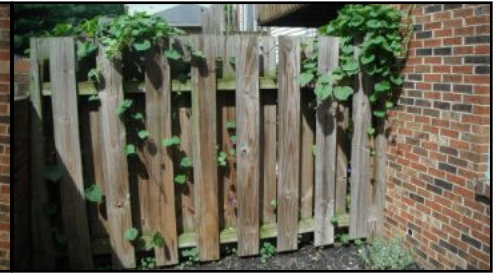
Vegetation growing from neighbor's side

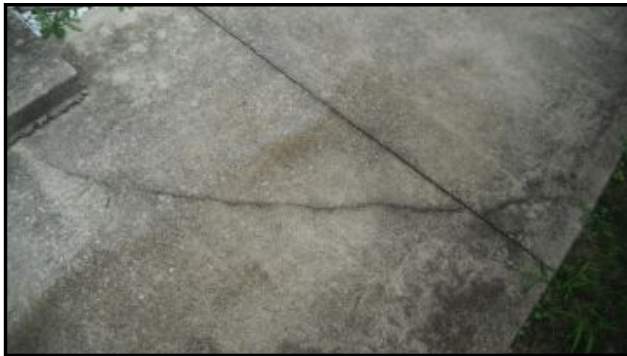
Normal cracking observed

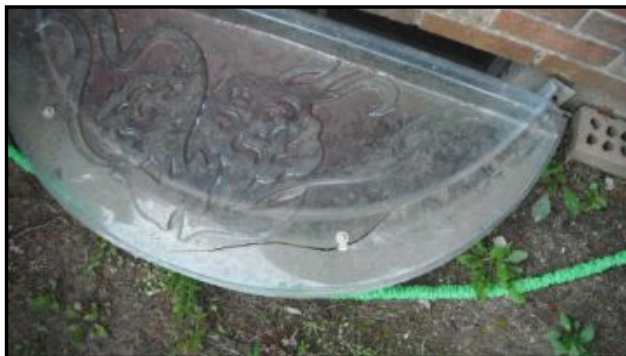
- Broken/cracked window glass noted at time of inspection at one or more locations, repairs recommended.
- No deficiencies noted at the time of inspection.

Window Well Cover Cracked

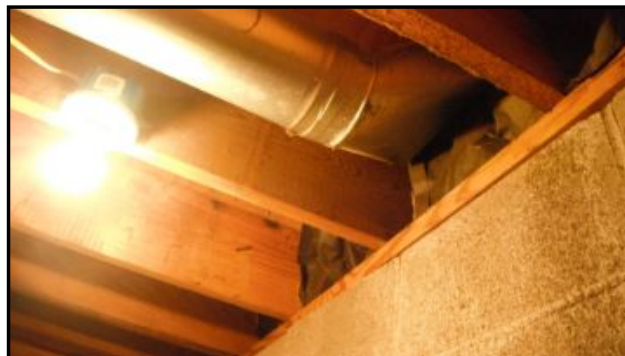
Suggest insulating for higher energy efficiency

- Recommend sealing all gaps, cracks and holes in the HVAC duct system for increased efficiency and lower energy bills.
