# *Ohio Home Inspection Organization*

## **Property Inspection Report**

123 Main Street, Mayberry, Ohio 43555  
Inspection prepared for: John & Jane Doe  
Real Estate Agent: -

Date of Inspection: 7/13/2013 Time: 9:00 AM  
Age of Home: 1976 Size: 1328 Sq. Ft.  
Weather: 80 Sunny

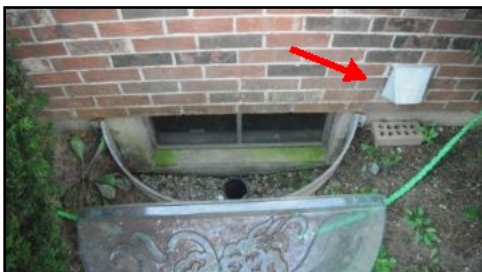
Dryer flex hose coming out of dryer

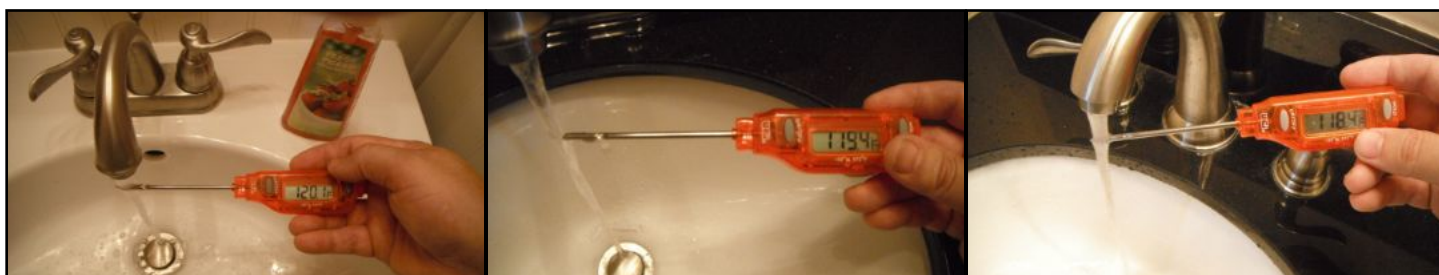
120 degrees hot water main floor    119.4 degree hot water upstairs    118.4 degree hot water upstairs

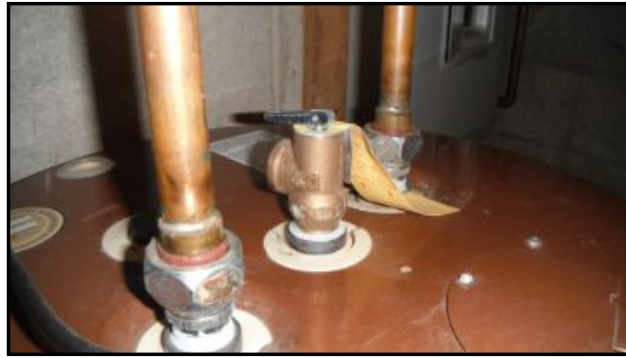
- Appears to be in satisfactory condition -- no concerns.

Functioned properly at the time of inspection

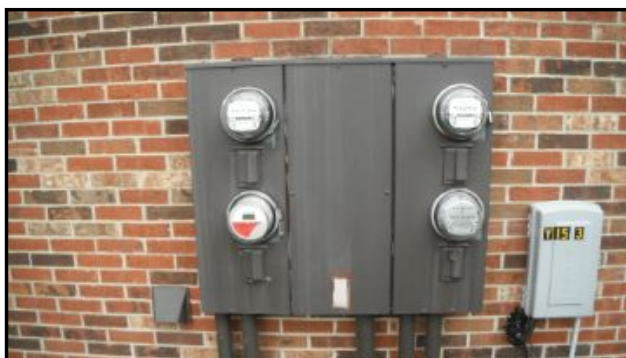
Located on North side of building

- Observed a GFCI breaker in the panel box, unsure where it goes or what it feeds.
- No major system safety or function concerns noted at time of inspection at main panel box.

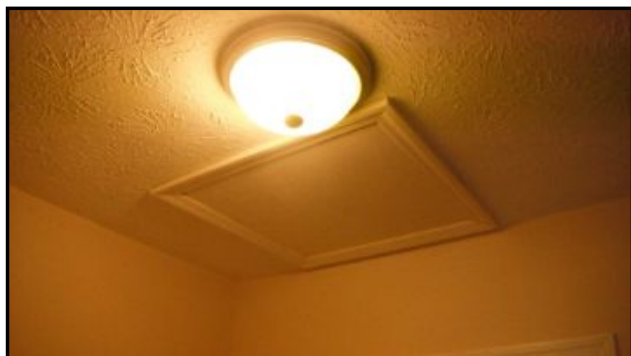
- Scuttle Hole located in:
- Bedroom Closet.
- IMPROVE: The attic access is not insulated. Expect some energy loss through convection. Recommend insulating attic access hatch cover with a batt of fiberglass insulation to reduce energy expenses.

Upstairs walk-in closet access to attic

- No insulation over attic hatch; recommend installation, then sealing hatch with caulk to minimize heat loss.
- Insulation appears adequate.

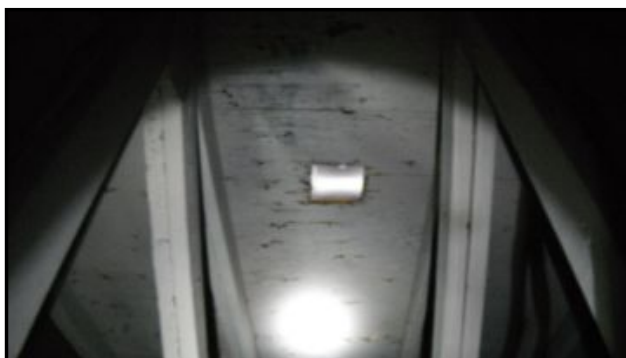
- Under eave soffit inlet vents noted.
- Fixed, roof-field exhaust vent noted.

Roof vent

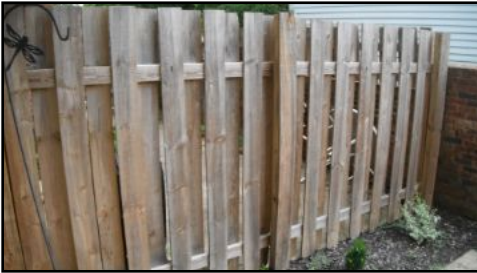
Nice Privacy Fence

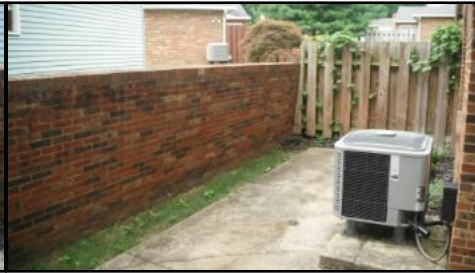
Nice, new Heat Pump

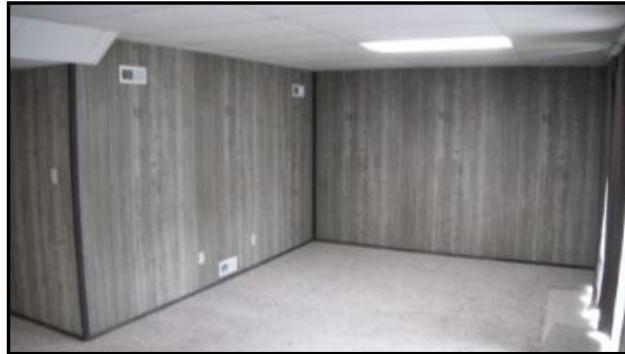
- The majority of the concrete basement floor slab was not visible due to floor coverings in the finished basement.

Carpeting and a suspended ceiling.

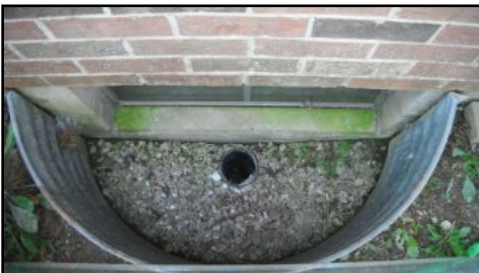
- Although a home inspection is visual and non-intrusive, there were no deficiencies noted with drainage as it pertains to the downspouts at the time of inspection. For further evaluation, consult a qualified, licensed, and bonded contractor.

Basement Window Well, drain noted

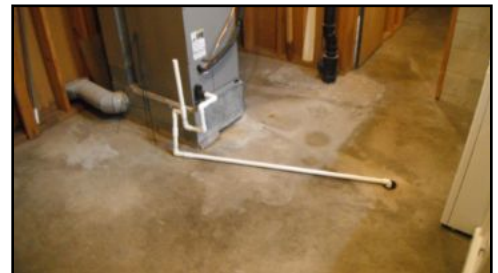
Condensate line from furnace going in to floor drain
